THE CALIFORNIA EARTHQUAKE OF APRIL 18, 1906

STATE EARTHQUAKE INVESTIGATION COMMISSION

IN TWO VOLUMES AND ATLAS

ANDREW C. LAWSON, CHAIRMAN

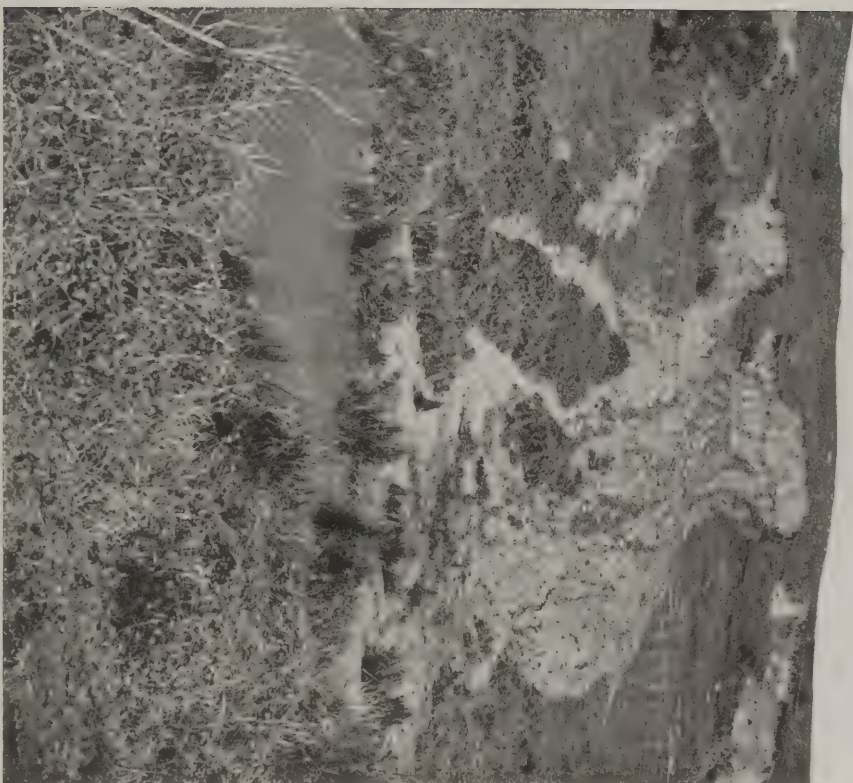
B. South part of Inverness shoal, at low tide, April 28, 1906. Looking north-northwest. Lane of water separates from, gravelly beach from mud shifted shoreward by earthquake. G. K. G.

At various places along the shore, from Inverness to a point 1.5 miles southward, the tidal mud seemed to be crowded against the firmer ground at the shore, being pushed up in a ridge, as shown in the accompanying photograph. (Plate 55B.) Two piers at Inverness, light wooden structures, resting on piles and extending out several hundred feet from the shore, were telescoped. (Figs. 26 and 27.) In the case of Martinelli's pier the telescoping was shown by the inclination given to piles at the landward and bayward ends, from which it appears that the ground in which the piles were set was crowded together, so that the foundation of the pier was shortened, while the superstructure resisted shortening. The resistance was temporary only, for before the agitation ceased the pier was broken in two; and the inclination of the piles is supposed to have been given during the early stages of the tremor. Coincident with the movement of the

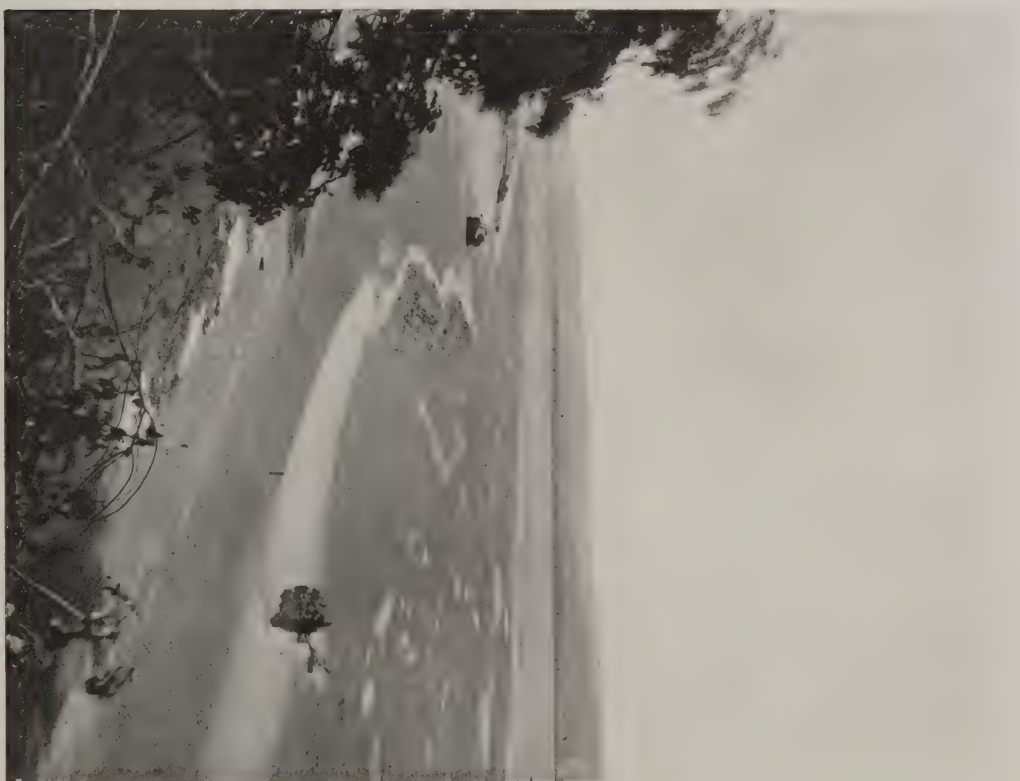
A. Ridges caused by earthquake on tidal flat of Tomales Bay, 1 mile south of Inverness. Looking north. December, 1906. G. K. G.

of 1907, and it was then overspread by a fresh deposit brought by Papermill Creek. The ridges varied somewhat in height, the amplitude from crest to trough ranging from 1 to 3 feet and possibly more. Their general trend was parallel to the fault-trace, but there were notable exceptions, and over small tracts the direction was even at right angles to it. In some cases, where the minor ridges were parallel, there were larger ridges traversing them obliquely. Fig. 25 reproduces a sketch map of the locality showing the greatest complexity. So far as the broad undulations of the tide lands were seen in conjunction with the ridging, the greater ridges were on the swells and not in the hollows.

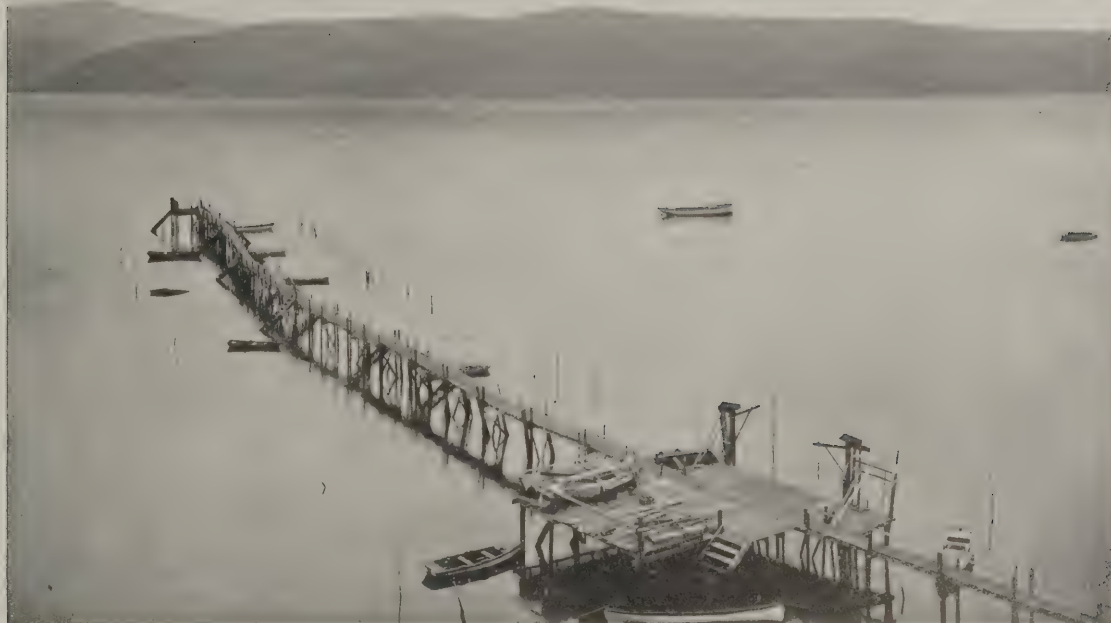
A. Bailey's pier at Inverness. Another view, position of camera being approximately same as in making photograph below, taken before the earthquake. G. K. G.

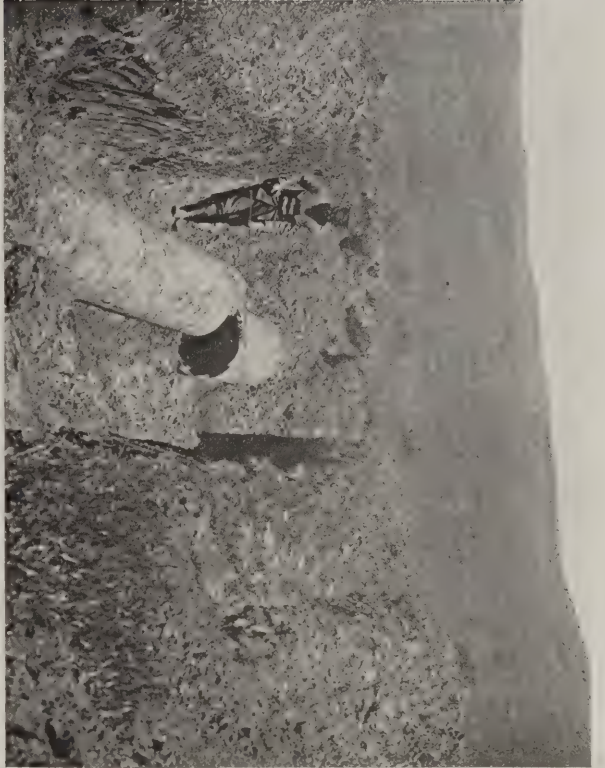
A. Offset in 30-inch water-pipe by fault. Northwest of San Andreas Lake. A. C. L.

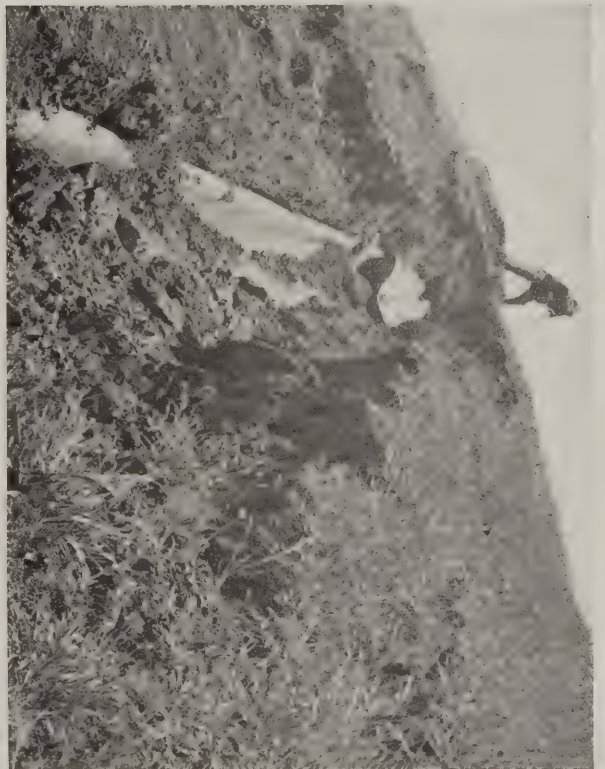
About 2 miles from the upper end of San Andreas Lake the fault encounters the 30-inch, laminated, wrought-iron pipe of the Spring Valley Water Company, which prior to the earthquake conveyed the water from Pilarcitos Lake to San Francisco. The metal of the pipe is about 0.1875 inch thick and coated with asphaltum. The pipe is buried in the soil at a depth of 3 to 4 feet. The point of intersection is near Small Frawley Canyon. Here the course of the pipe swings from a northwesterly to a more northerly course, and the fault consequently intersects it at an acute angle. At the point of intersection, the pipe was obliquely sheared apart and telescoped upon itself, effecting a shortening of about 6 feet. The amount of the transverse offset involved in the shear was about half the diameter of the pipe. The portion north of the break was moved east and telescoped southerly. For 0.875 mile southeast of this point, the path of the fault lay on the northeast side of the pipe and nearly parallel to it, but a short distance away. About 220 yards southeast of the intersection, where the pipe, buried a few feet below the surface, ascends a rising slope, the pipe had completely collapsed for a distance of several

yards, due doubtless to the establishment of a partial vacuum within the pipe by the sudden withdrawal of the water from the arch in the pipe at the time of the shock, owing either to the leakage below, or the propulsion of the water induced by the shock. (See plate 60B.)

F. Collapse of 30-inch water-pipe northwest of San Andreas Lake. F. L. H.

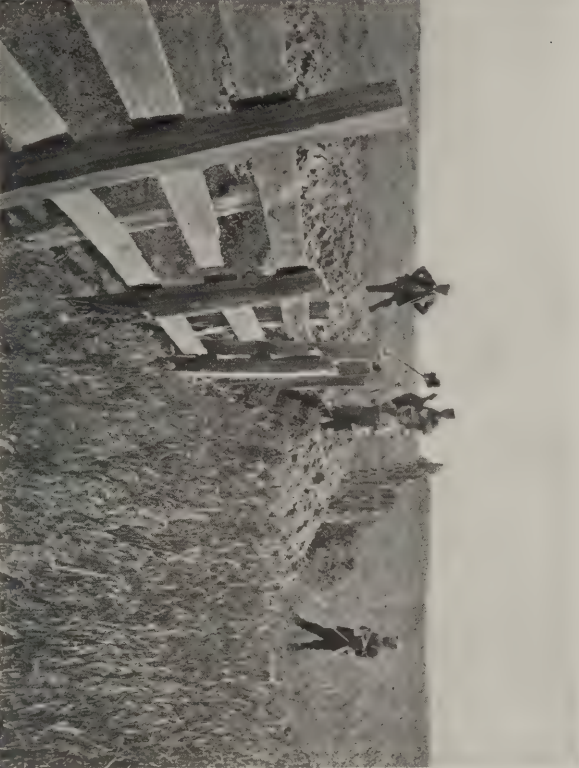
furrow. The movement was in the same direction as before, therefore a pulling apart of the pipe took place instead of a compression. There occurred two breaks in the pipe (see plate 59A), the main one at the crossing of the fault, and the other 150 yards away on the northeast side of the fault, but very near it, the pipe being almost parallel with it. At the main break, the pipe was pulled apart 59 inches, and at the other one 21.5 inches, making a total displacement of 6.666 feet. The pipe was not quite parallel with the fault and therefore there was a slight offset, at right angles to its direction, of 4 inches at the main break and 2 inches at the minor one, or a total of 6 inches. A fence which crossed the fault at the main break is offset 6.5 feet. (Plate 60c.)

C. Offset of 6.5 feet in fence, northwest of San Andreas Lake. F. L. H.

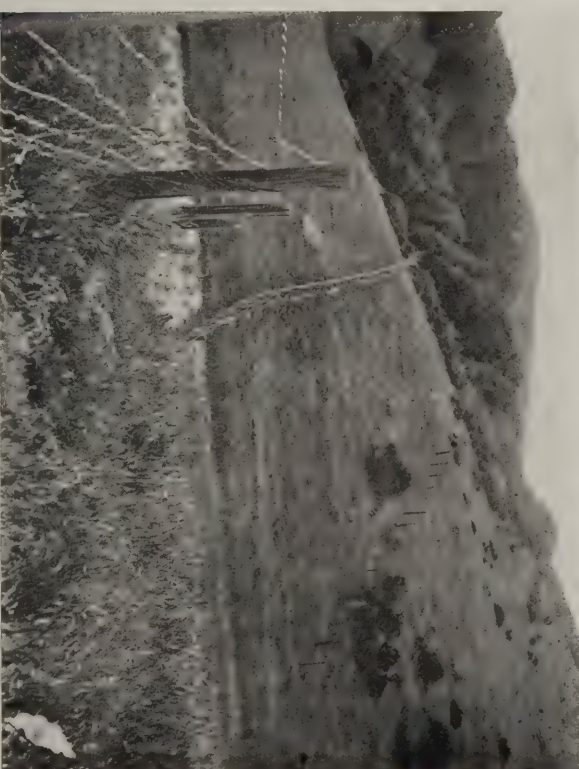
D. Offset of 6 feet in fence between San Andreas and Crystal Springs Lakes. Per J. C. B.

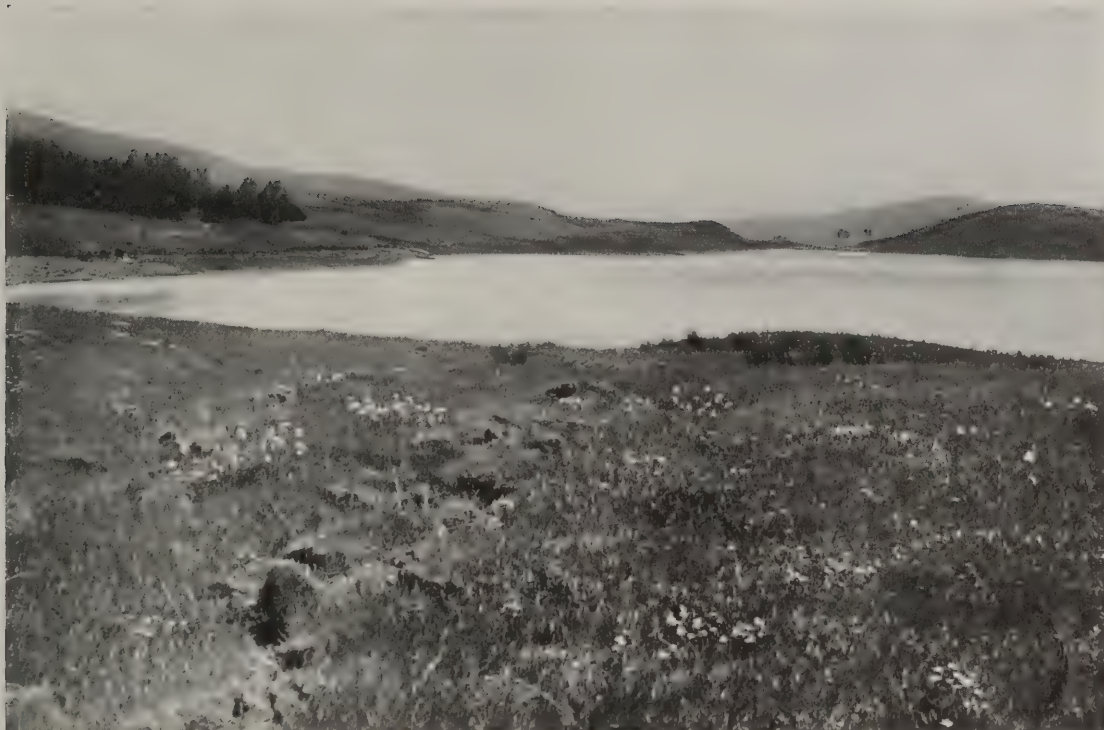
lake for the first 0.875 of a mile of its length. It then enters the water (plate 61D) and follows the northeast side of the lake, a little distance from shore, to the San Andreas dam at the lower end of the lake. In this distance of nearly 2 miles, the fault-trace emerges from the water at a number of points where little capes project into the lake. The crossing of these capes by the fault-trace indicates that it follows a very straight course beneath the water of the lake. On the last of these promontories traversed by the fault, the main fault-trace has associated with it a number of auxiliary cracks. Between the main fault-trace and one of the diverging cracks, on the southwest side of the fault, is a brick and cement gate-well in connection with the tunnel which takes the waters from the lake toward Millbrae. This gate-well was circular in cross-section, the inside diameter being about 26 feet. The nearest point of the structure to the main fault-trace is within 5 feet.

A. Fault-trace where it passes into San Andreas Lake. D.

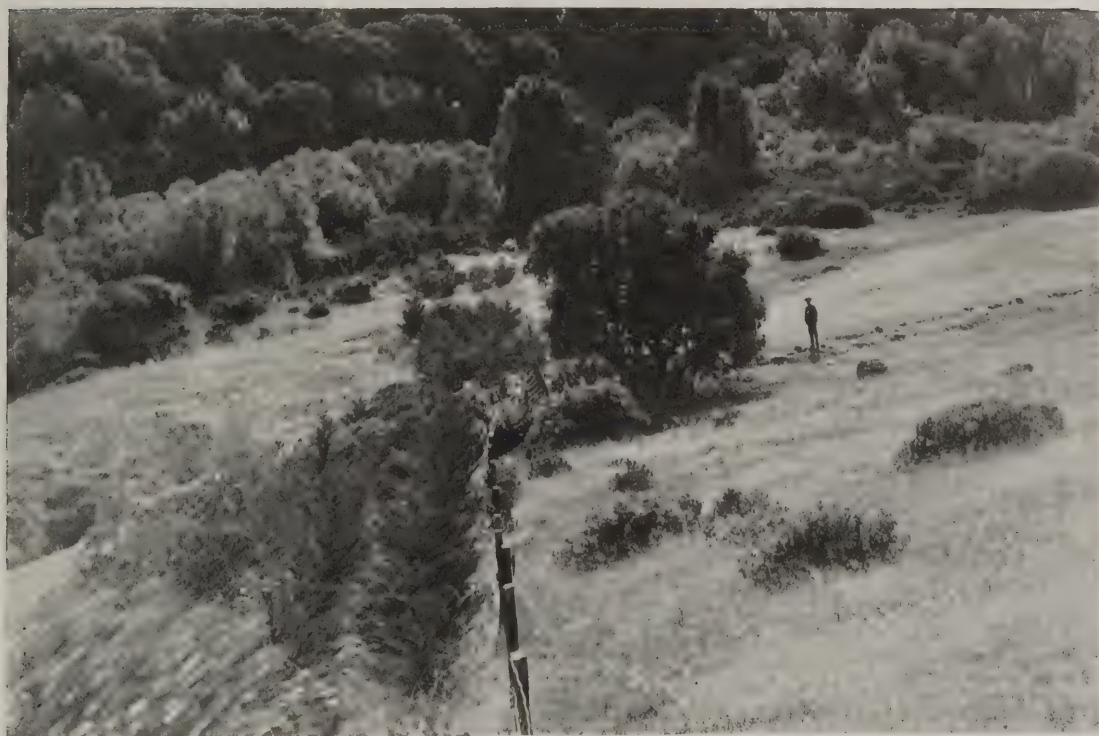
B. Offset fence near Crystal Springs Lake. R. A.

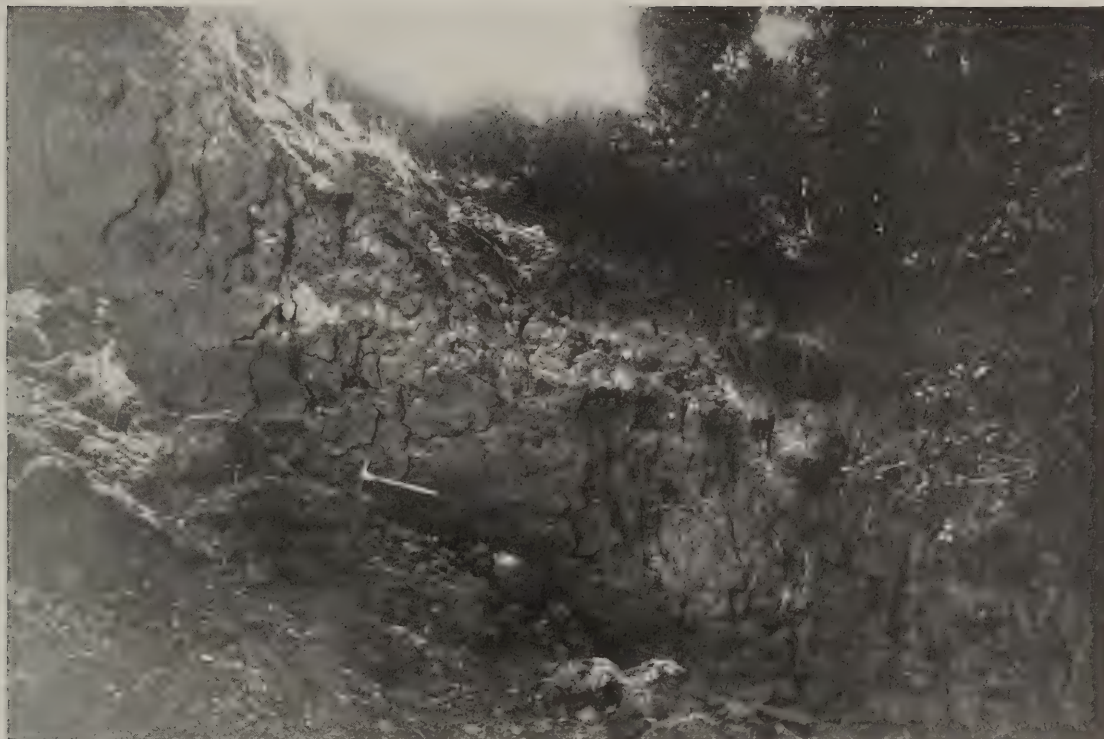
A. Exposure of slicken-sided fault plane near north end of Crystal Springs Lake. R. A.

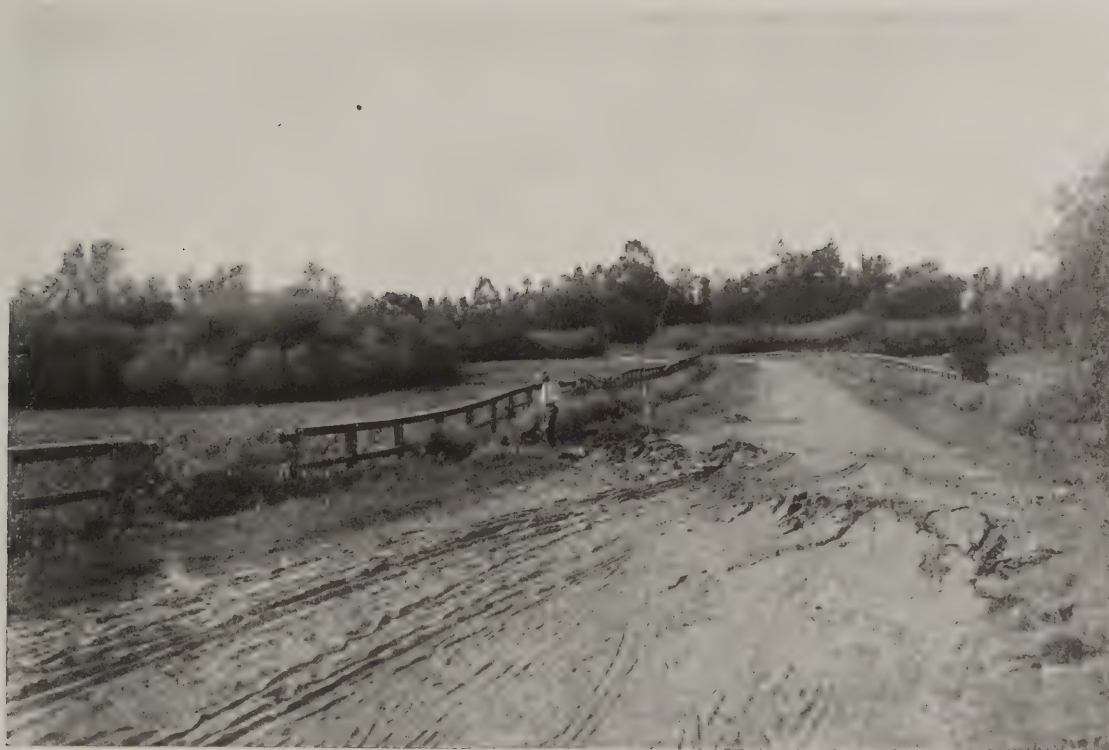
B. Offset of road by main fault near Searsville reservoir. Per J. C. B.

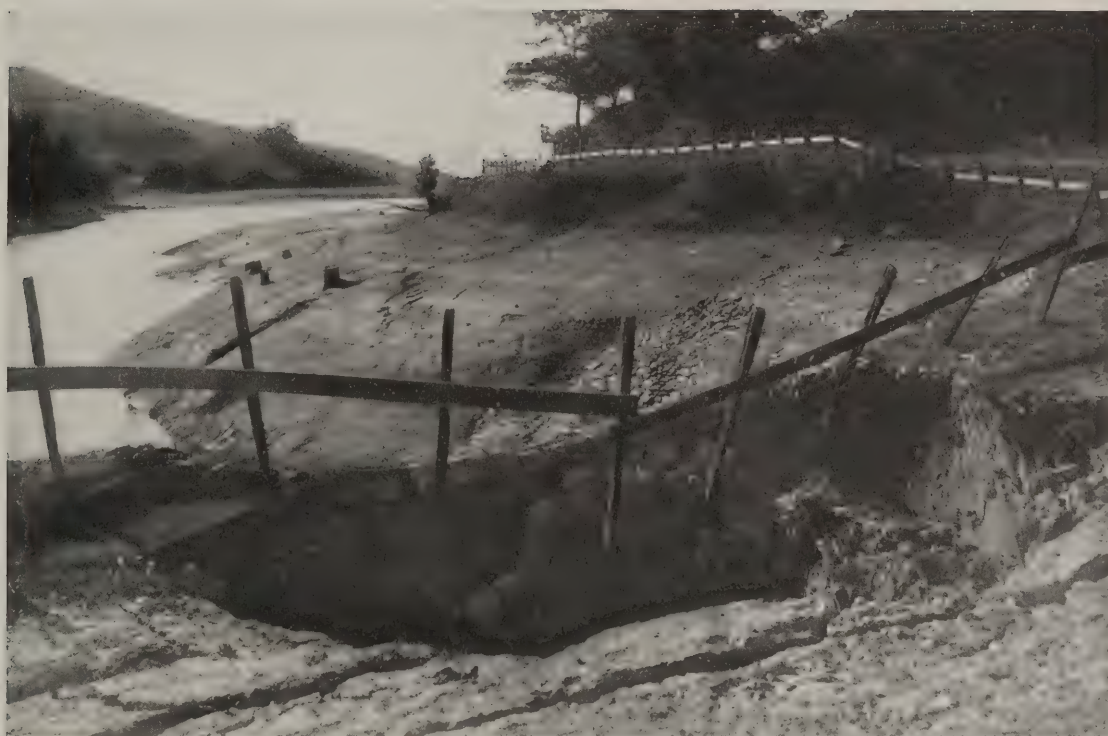
South of Congress Springs. — Near and northwest of the reservoir 2.5 miles southeast of Congress Springs, fissures from 4 to 6 feet wide ran nearly north and south, and past thru the earthen dam at the northwest end of the reservoir. (Plate 64A.) The intake pipes at the south end of the reservoir were disconnected, and the escaping water undermined a part of the southern dam of the reservoir. This reservoir is in a topographic saddle and has dams at both ends. The fault-trace passes thru this saddle. Where the bottom of the reservoir was exposed by the escape of the water, cracks of the fault-trace were exposed in the mud. Fences crossing the fissures showed but little displacement; the displacement moved the northeast side toward the southeast, relatively. The hills southeast of the reservoir have steep slopes of from 20 to 50 degrees. The cracks follow the east-facing slopes and the east side of these cracks had raised about 6 or 8 inches. Southeast of the reservoir the chimneys and water-tanks were down.

A. Reservoir in saddle south of Saratoga traversed by main fault. D.

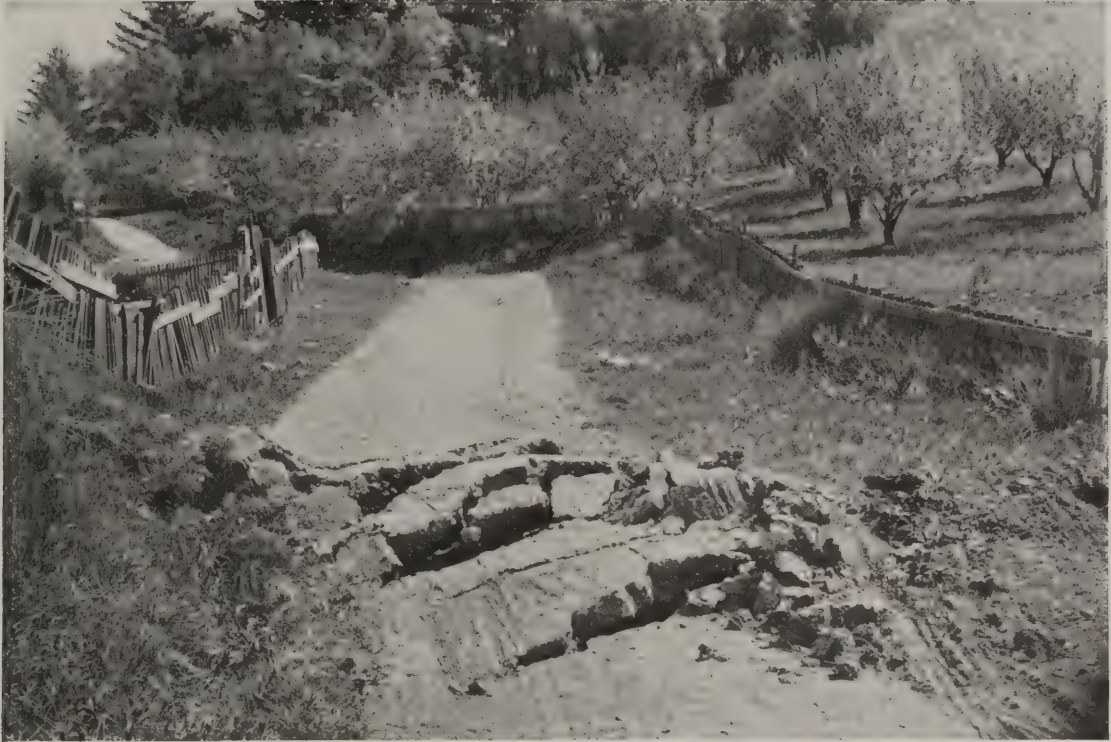
A. Offset in road near Wright. G. A. W.

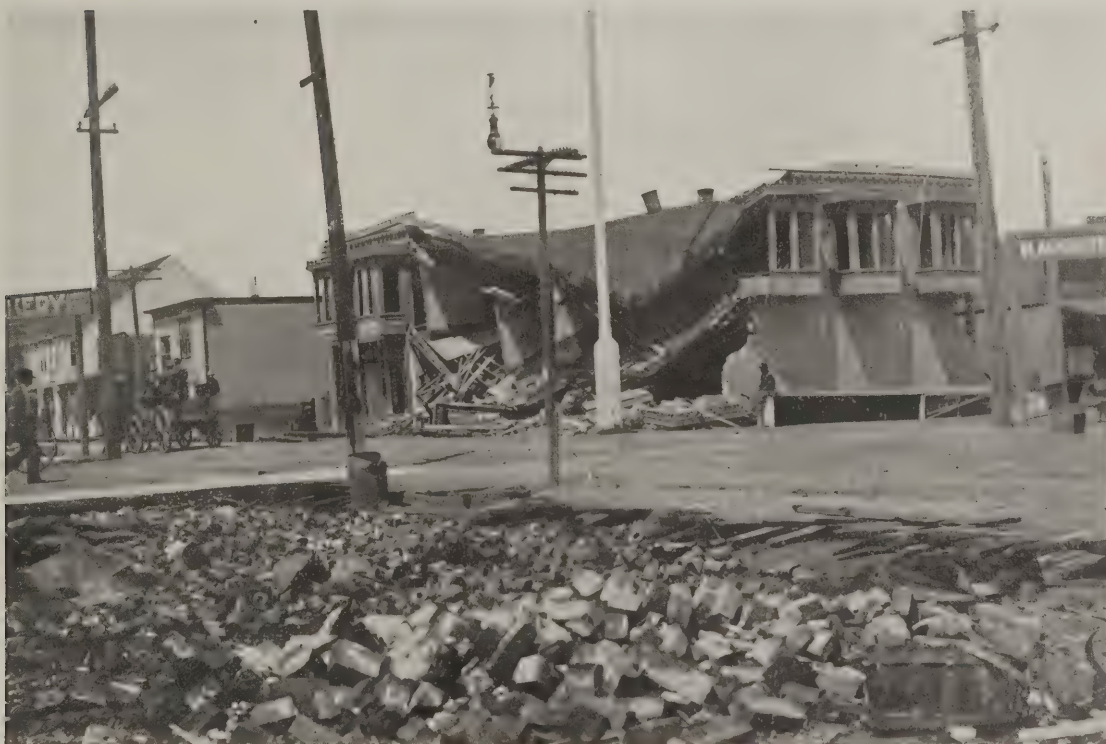
B. Wrecked buildings, Fort Bragg. Looking northwest.

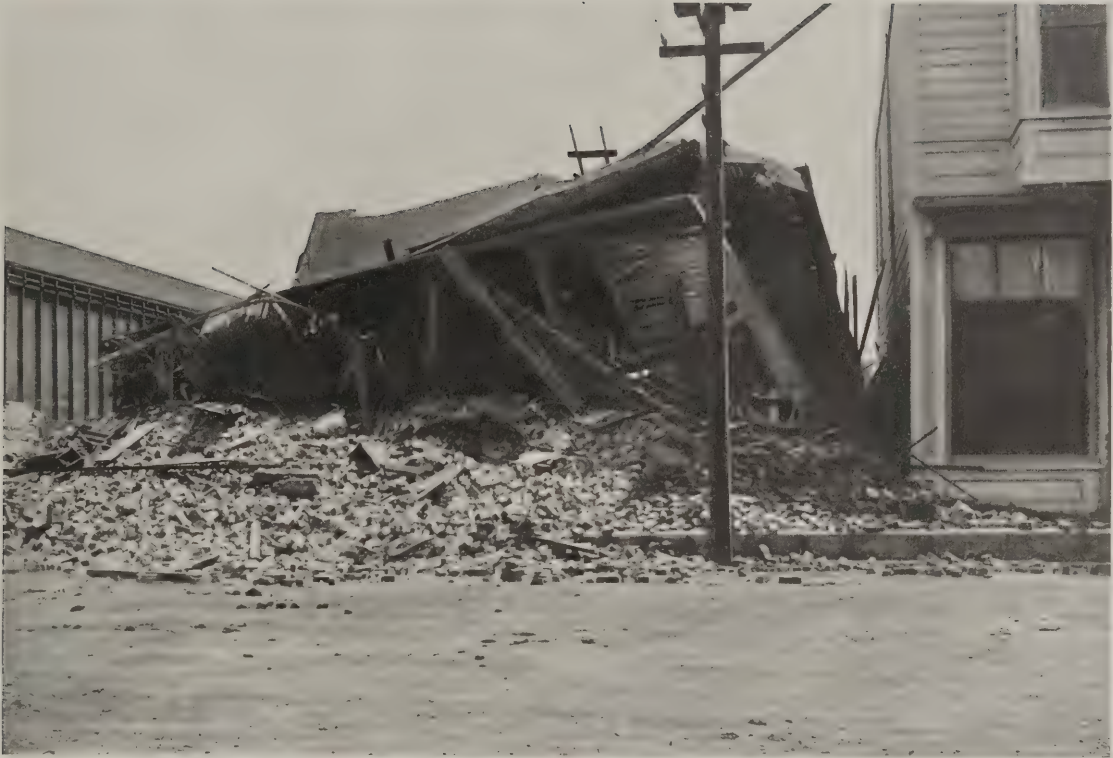
A. Odd Fellows' Hall, a 3-story brick building. Fort Bragg. Looking east.

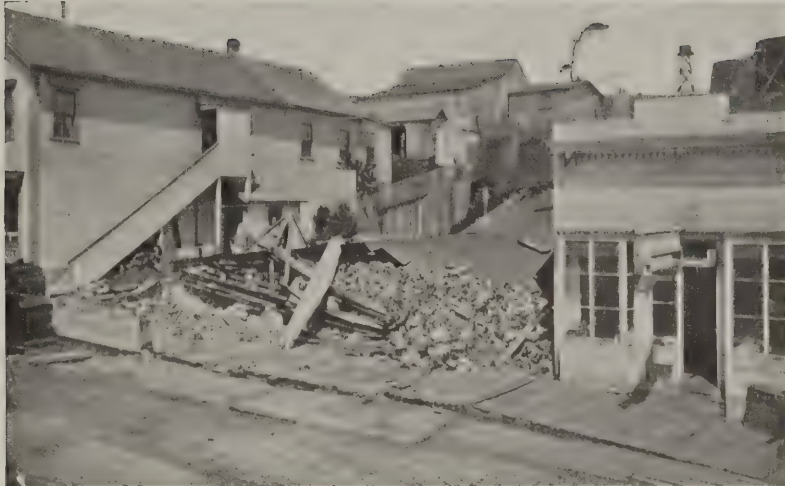
A. Point Arena. Brick house destroyed; wooden houses little affected. F. E. M.

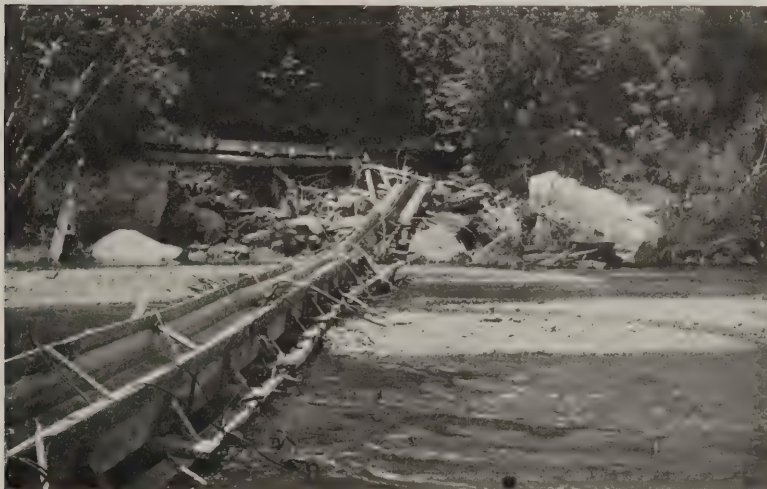
B. Wreck of suspended flume across Garcia River. Looking west. F. E. M.

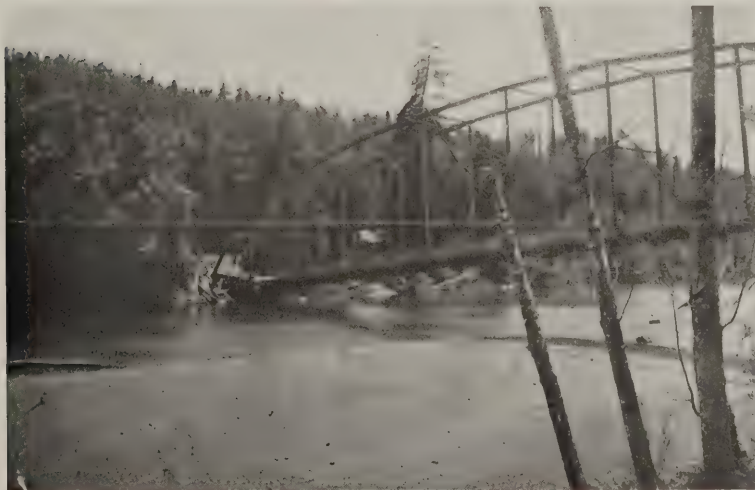
C. Collapsed wagon bridge over Gualala River. South end dropt 20 feet. F. E. M.

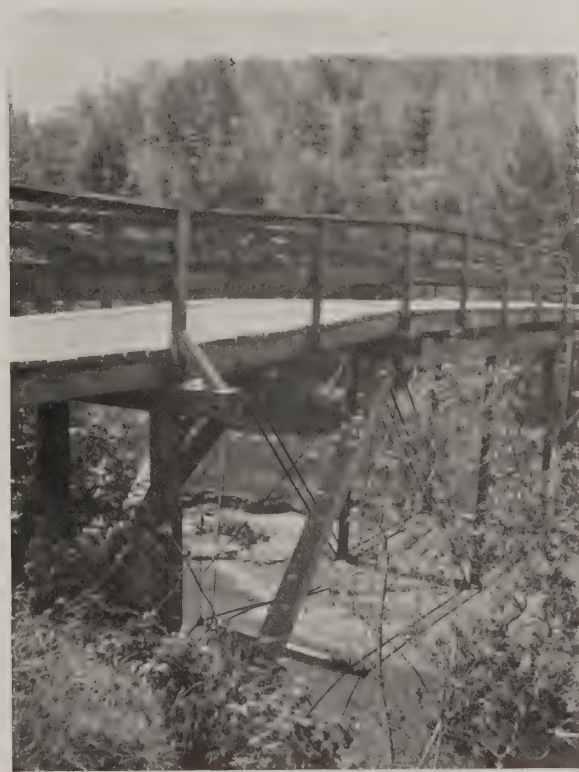
D. Bridge over South Fork, Gualala River, 3 miles east of Stewart's Point, looking north. Bridge floor and panels bent; tension rods buckled. F. E. M.

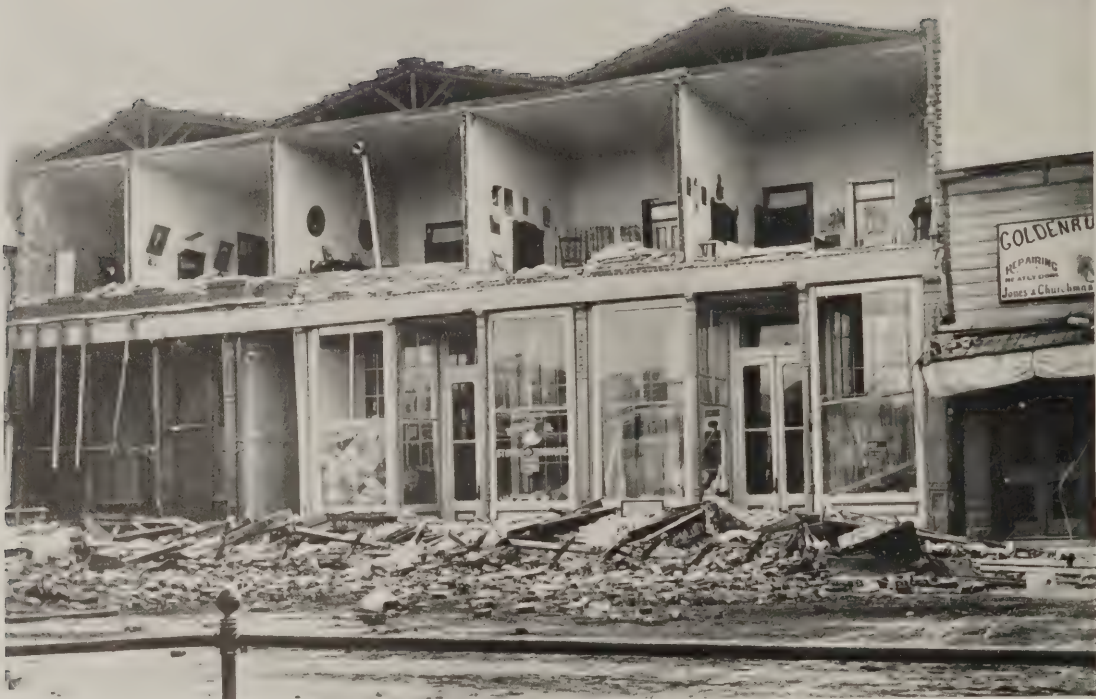
A. Bell and Kinslow building, Healdsburg. Per J. C. B.

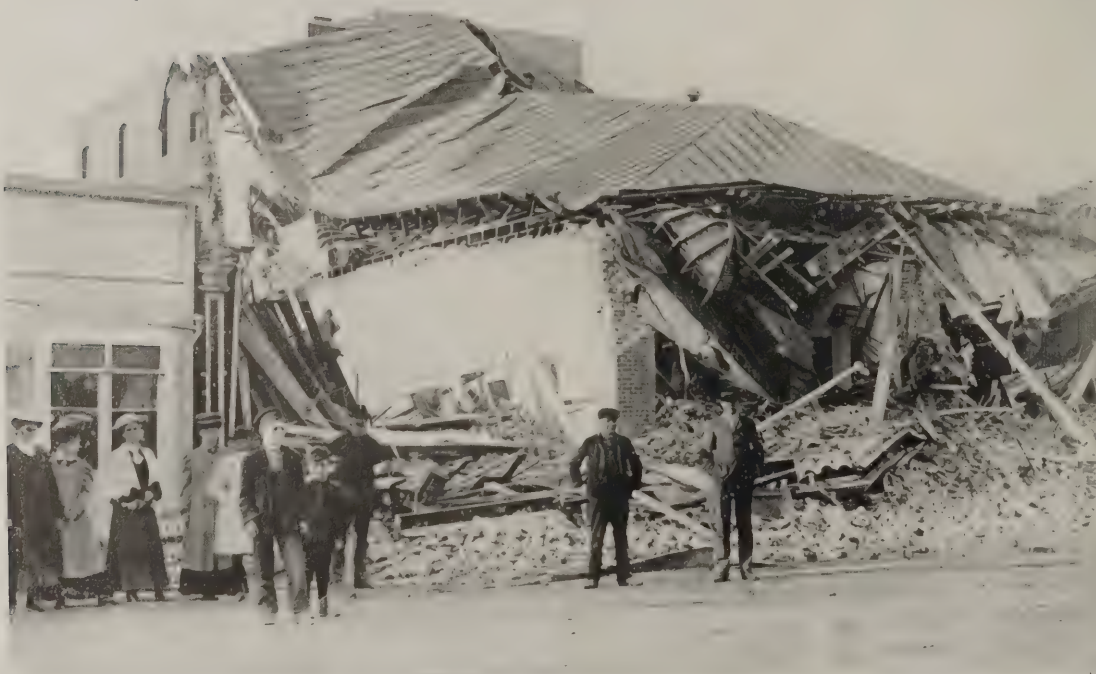
B. Odd Fellows' Hall, Healdsburg. Per J. C. B.

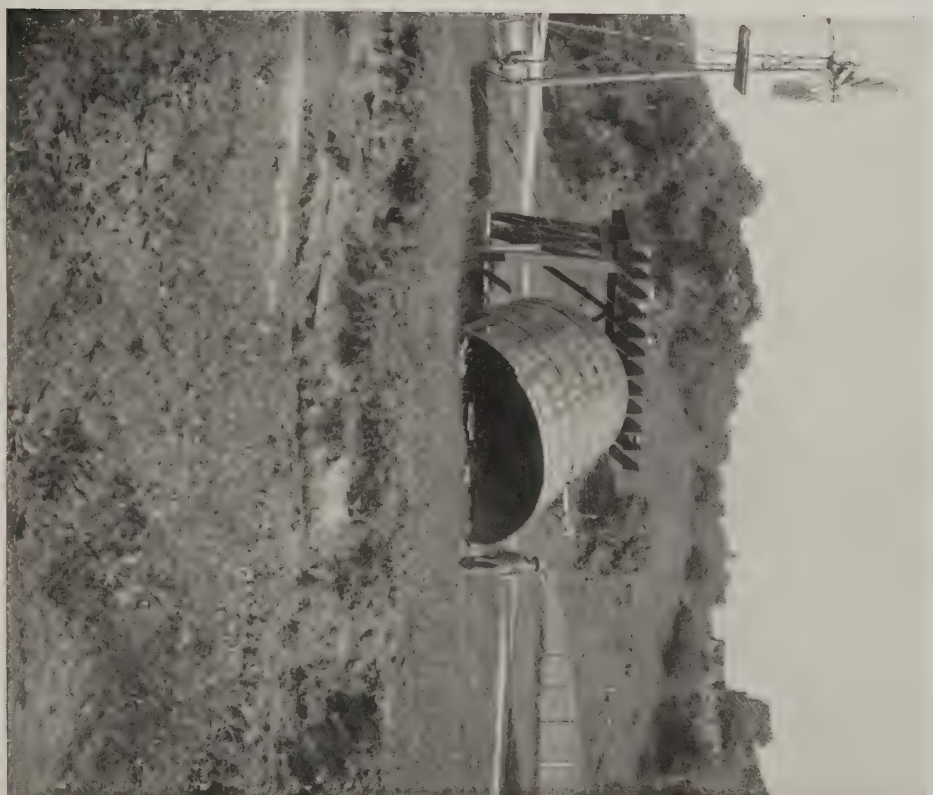
B. Wrecked water-tank, near Inverness. G. K. G.

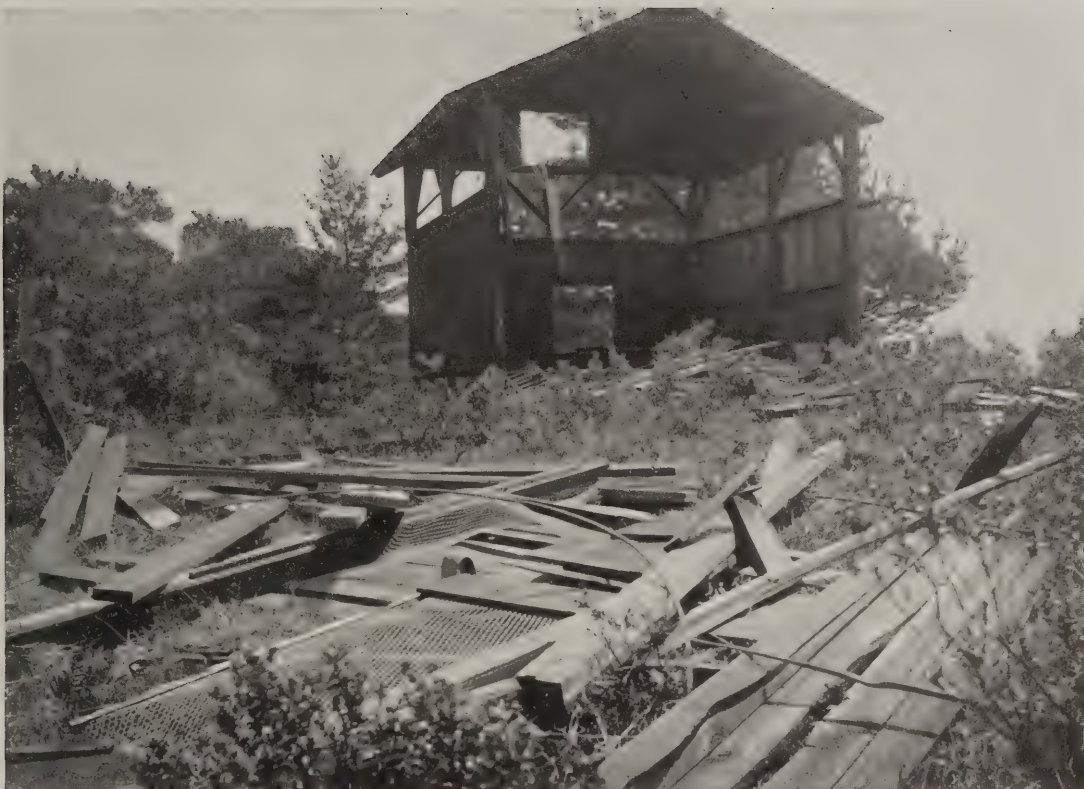
A. Ruin of Inverness reservoir, a circular tank which before earthquake stood in shed. Parts of shed also lie in foreground, about 50 feet from original position. G. K. G.

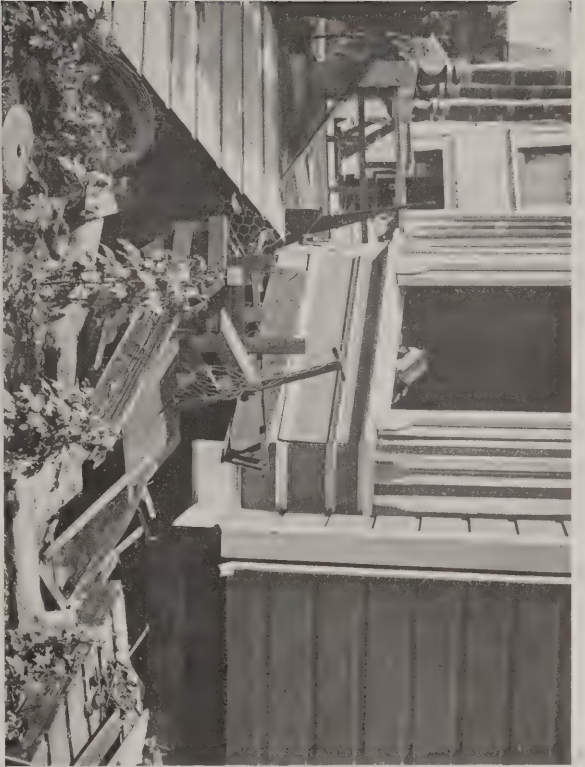
A. House moved 7 feet by collapse of underpinning, Santa Rosa. R. S. H.

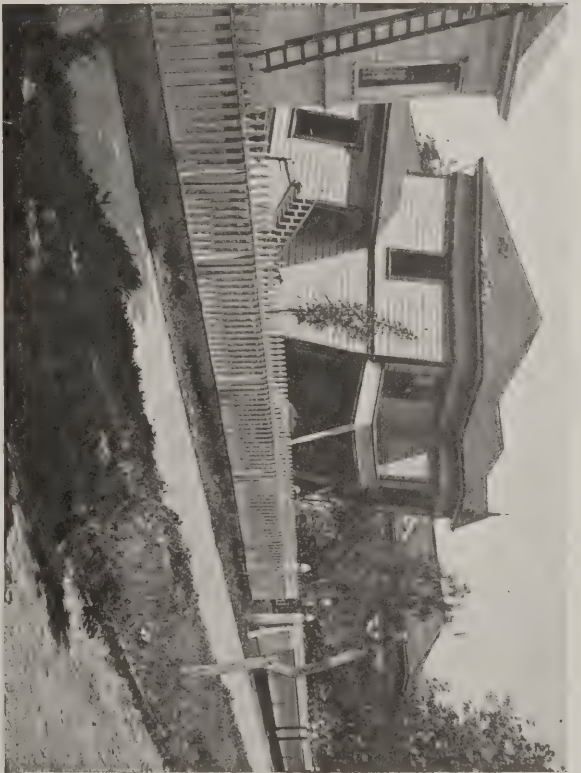
B. House lurched to north, Santa Rosa. R. S. H.

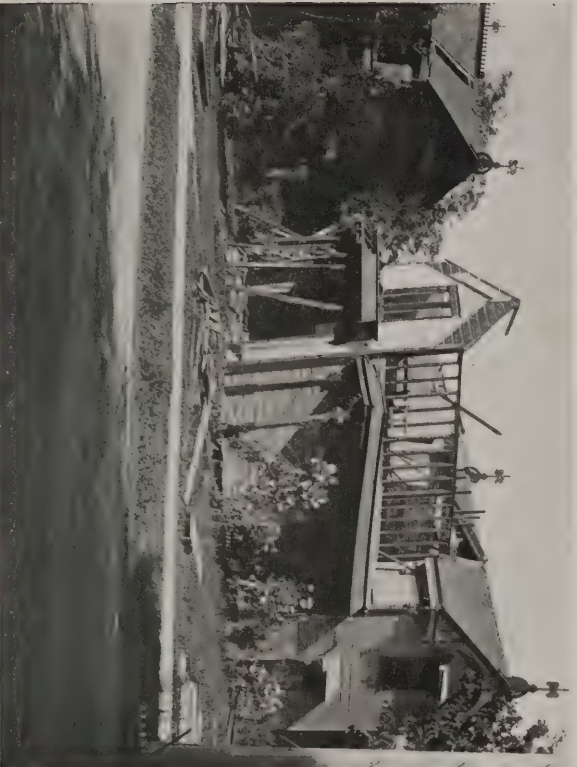
C. Wrecked dwelling, Santa Rosa. R. S. H.

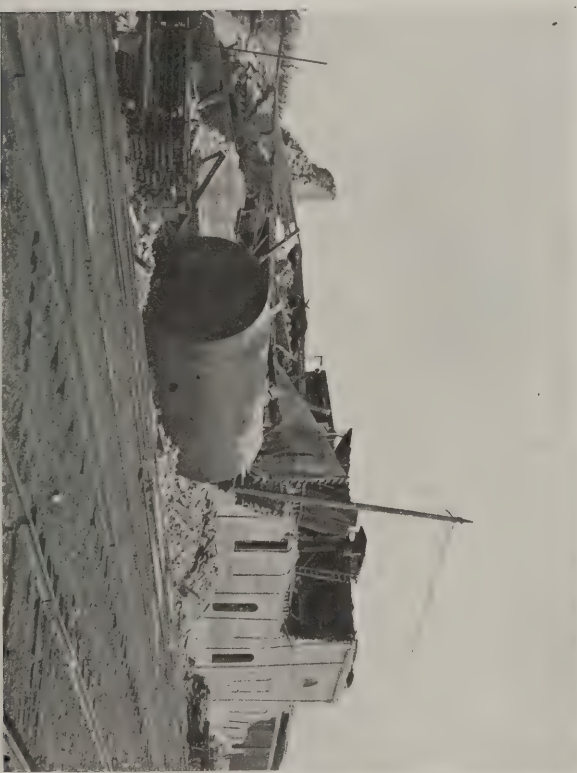
D. Wreck of brick structure, Santa Rosa. R. S. H.

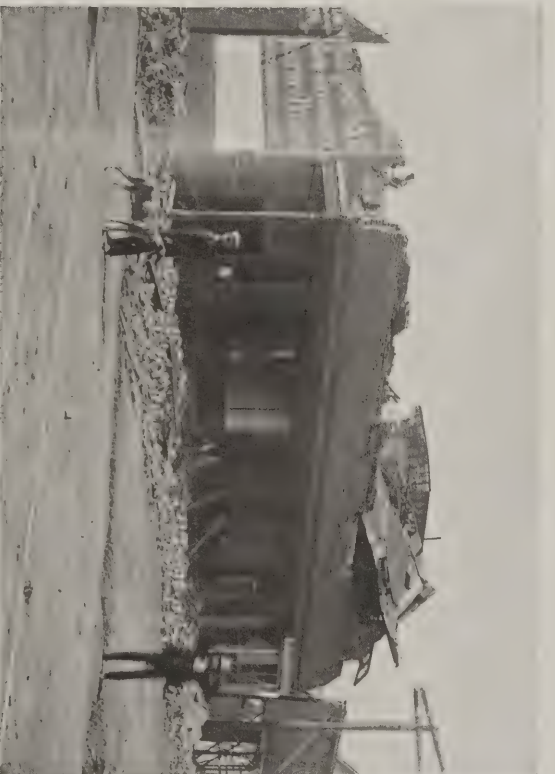
B. Wrecked buildings, Sebastopol. R. S. H.

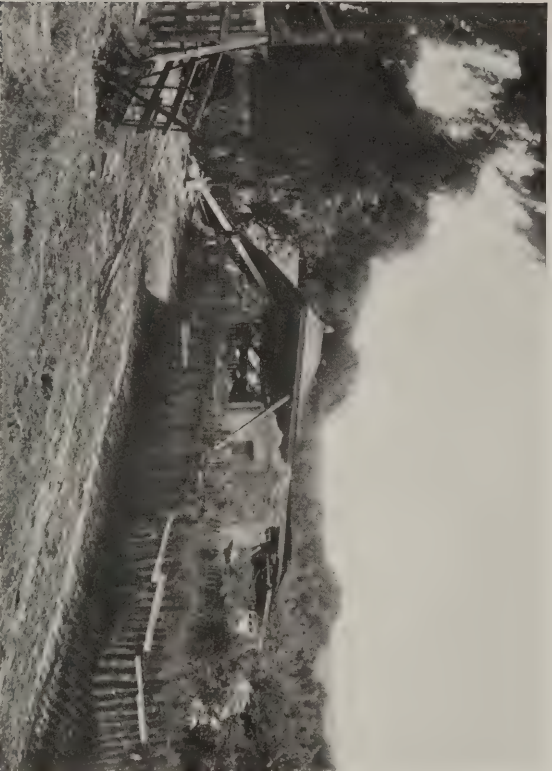
C. Stone house 1.5 miles southeast of Tomalas, where two people were killed at time of earthquake. R. S. H.

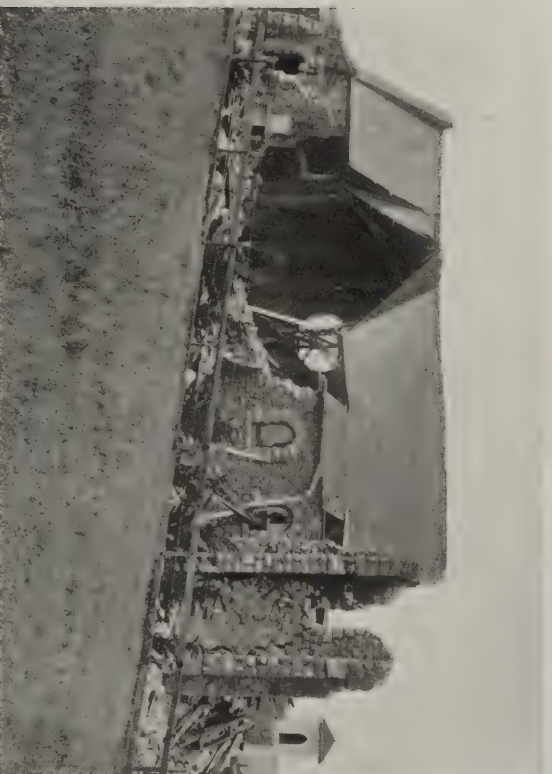
D. Wrecked church, Tomalas. R. S. H.

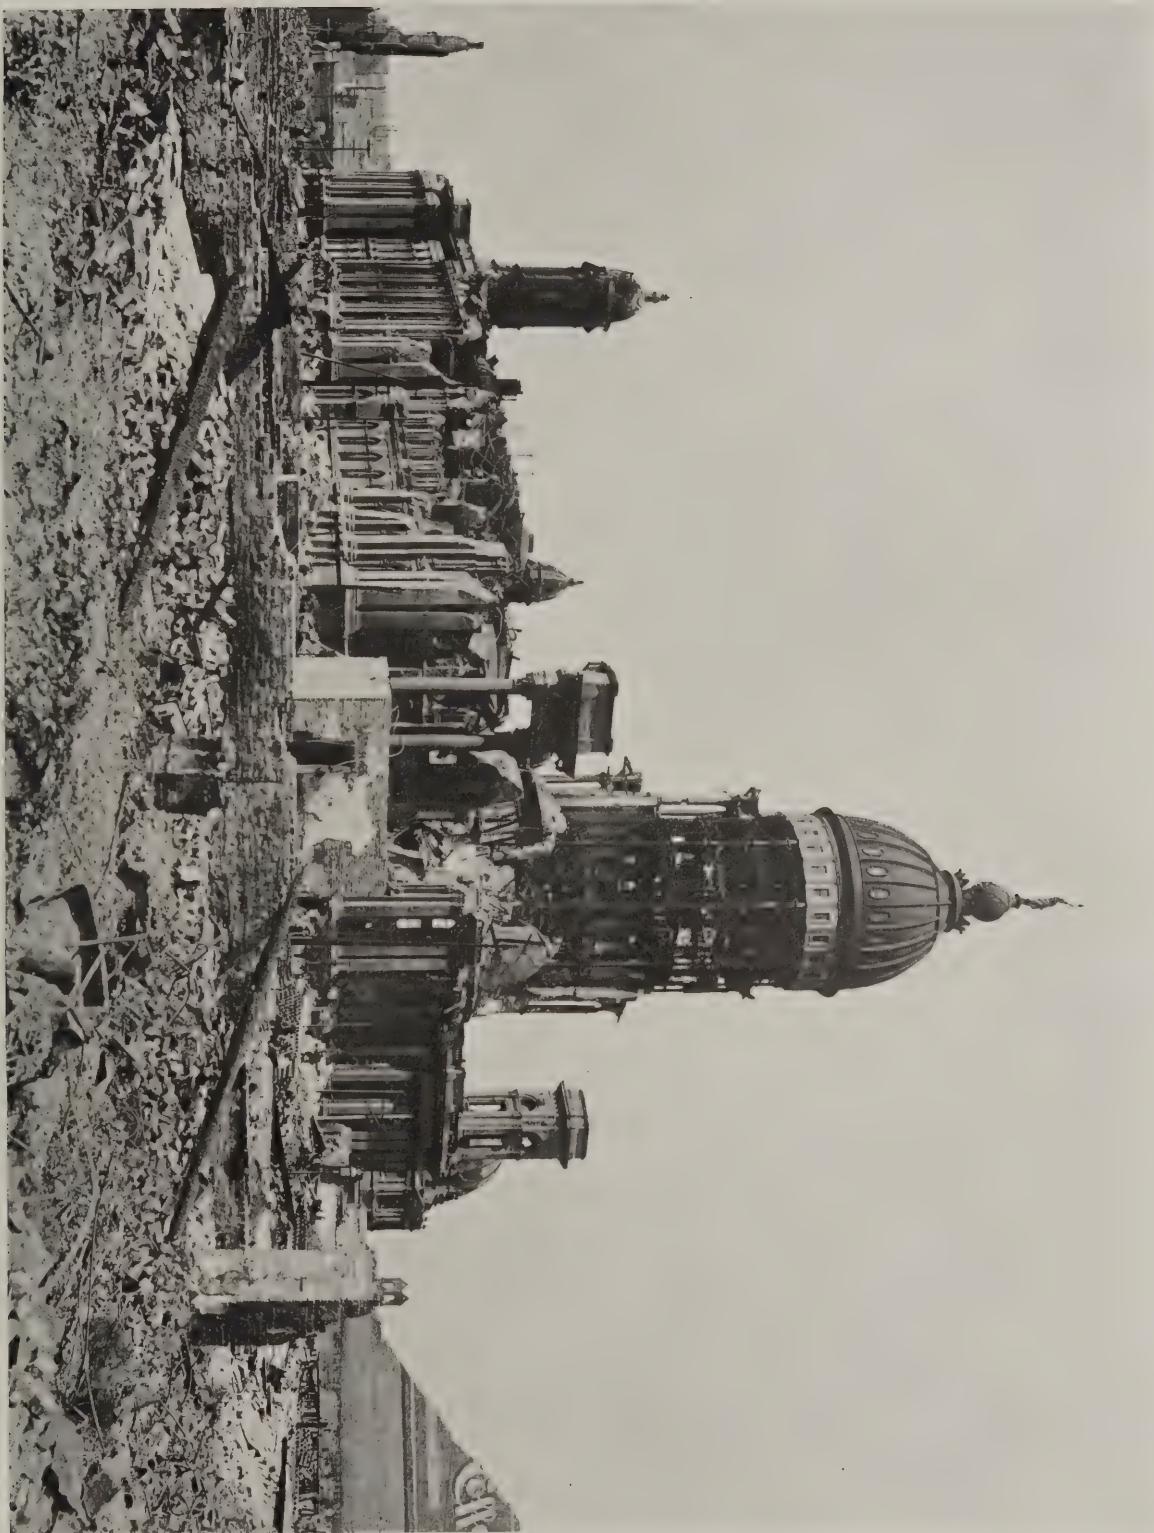
City Hall, San Francisco.

Near the City Hall there was a small locality conspicuous for the damage produced. The City Hall itself made a picturesque ruin (plates 82 and 83A), as all the world knows, but the character of the construction was probably a large factor in its destruction. Nevertheless ugly cracks in other buildings near by indicated intensity somewhat higher than was common in the valley district as a whole.
